AL BALDA POLICE STATION
HILLA, IRAQ

SIGIR PA-05-015
JANUARY 27, 2006

SUBJECT: Report on Project Assessment of the Al Balda Police Station in Hilla, Iraq
(Report Number SIGIR-PA-05-015)

Project Assessment of the Al Balda Police Station in Hilla, Iraq

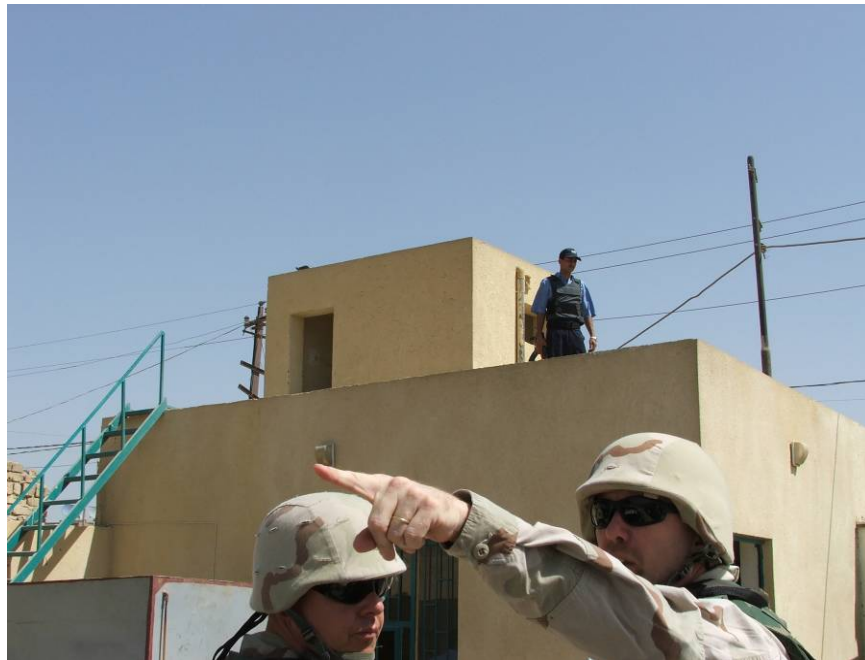
The contract's BOQ required new construction, repair, and upgrade (height) of the perimeter wall; construction of four corner guard towers; supply and installation of 250 meters of concertina barbed wire; installation of 300 square meters (M²) of paved parking area; installation of 150 M² of sidewalks; and installation of an entry gate. During our site visit, we observed that the perimeter walls were in place and were painted, and that four corner guard towers were complete. Concertina barbed wire was located on top of all perimeter walls and on the Police Station's roof. The parking area was paved with asphalt and concrete sidewalks were located around the police station buildings. The upgrade of perimeter security appeared consistent with contract requirements.

Site Photo 1. Corner Guard Tower

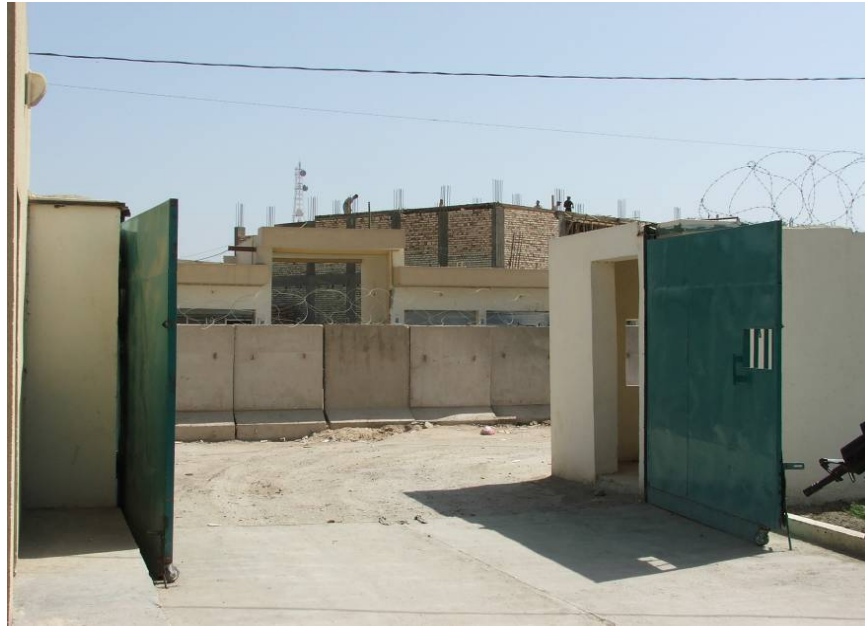
Site Photo 2. Main Entry Gate

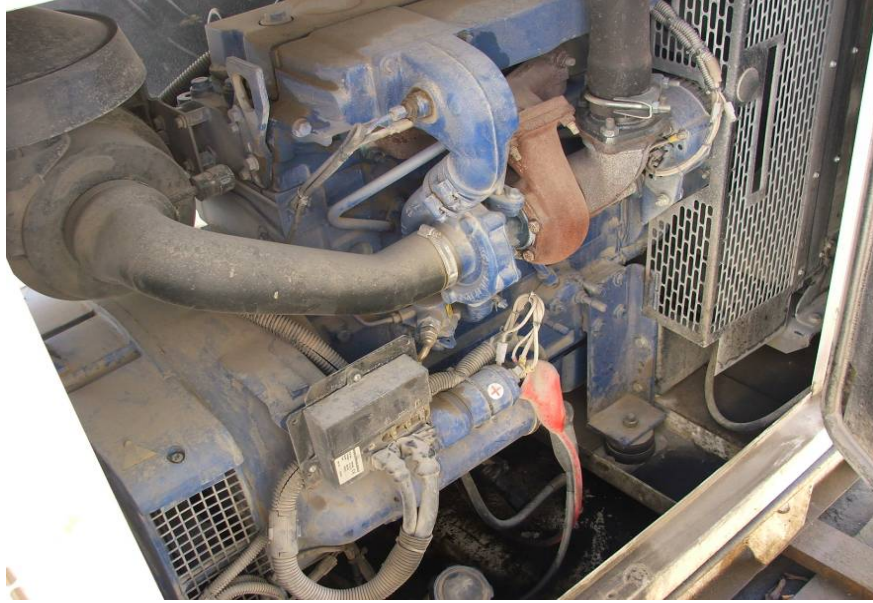
Contract Modification #P0001 required the supply and installation of a generator and a fuel tank. The contract did not specify the size of the generator required. The generator and fuel tank were on site and located to the right of the inside perimeter main gate. The generator factory nameplate lists the following information: company name - FG Wilson (Engineering) Ltd, Model - XP83E1, Serial Number - FGWPEP03ED0A24307, Year of Manufacture - 2004, Rated Power - 82.5 kilo Volt Amp (kVA), Rated voltage - 400/230 V, Rated Frequency - 50 Hz, and Rated Current - 119 A. For an illustration of the generator housing, and the 82.5 kVA generator inside the housing, see Site Photo 4 and Site Photo 5, respectively.

Site Photo 5. 82.5 kVA Generator

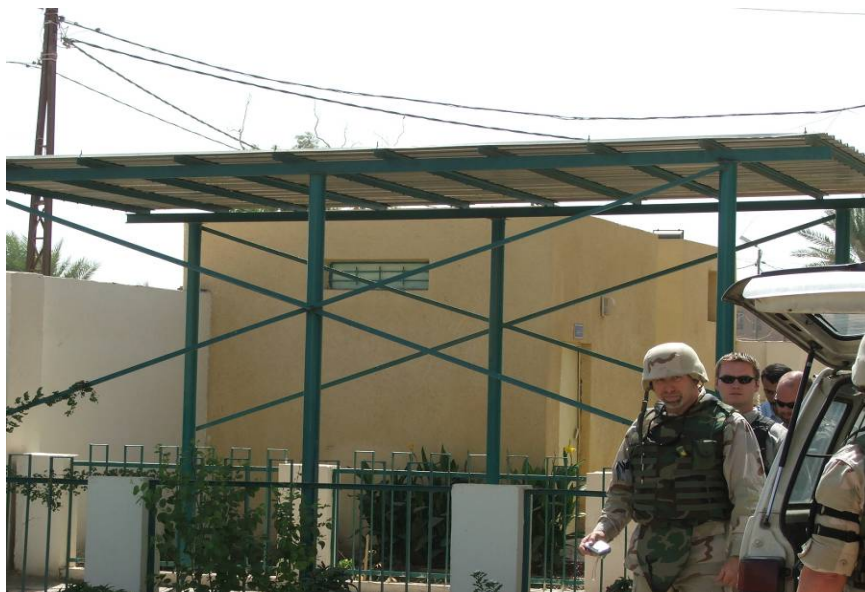
- Construction of covered entrance
Contract Modification #P0001's BOQ required the new construction of 99 M² of canopies with steel frame supports and corrugated steel sheet roofs. A new canopy was located between the pedestrian gate and the front door of the Police Station. In addition, a canopy used for automobile parking was located between the generator units and the newly constructed cafeteria building. Both canopies were composed of painted steel frames and corrugated metal roofs. During the site visit, no discrepancies were noted regarding the construction of the canopies. For an illustration of the entrance canopy and the automobile canopy, see Site Photo 6 and Site Photo 7, respectively.

Site Photo 6. Entrance Canopy

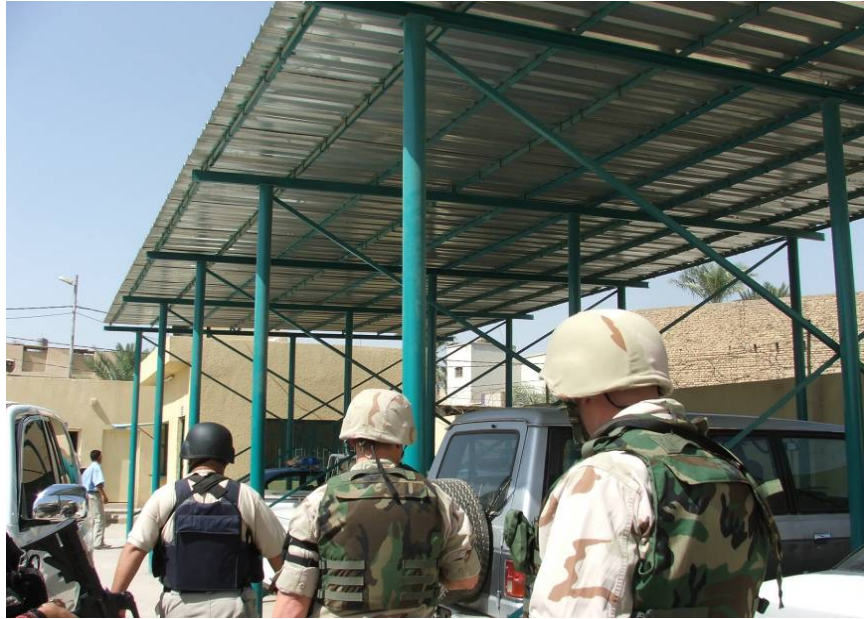
Site Photo 7. Automobile Parking Canopy

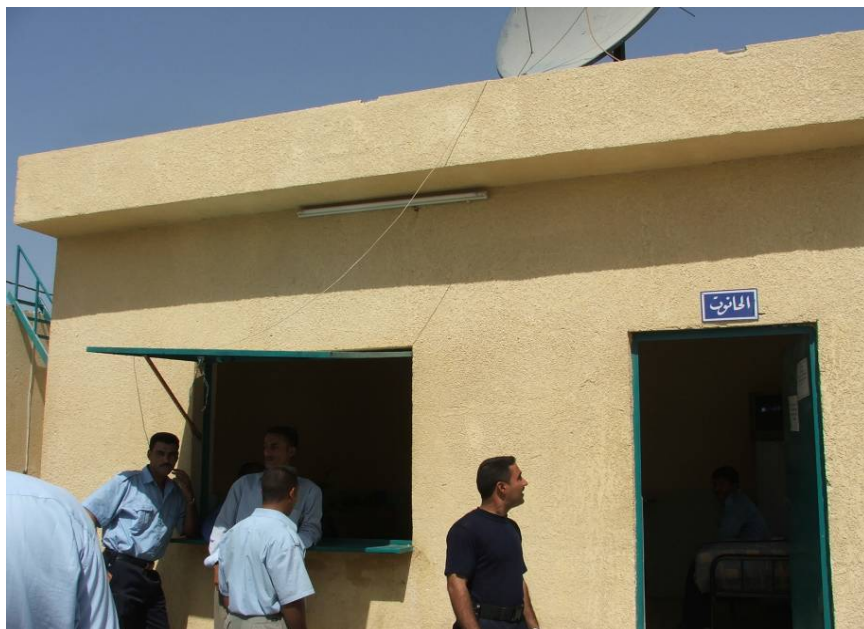
- Construction of four small building
The contract's BOQ required the construction of four small buildings with specific dimensions: (1) a dormitory building (4M x 9M), (2) a cafeteria building (4M x 5M), (3) an information building (4M x 6M), and (4) an arms storage facility building (4.11M x 5.62M). The site visit verified the buildings were constructed and were currently in use. For an illustration of the cafeteria building's exterior front, see Site Photo 8; the exterior of the information building can be seen in Site Photo 9. The buildings appeared to be consistent with the contract's requirements.

Site Photo 8. Exterior View of the Cafeteria Building

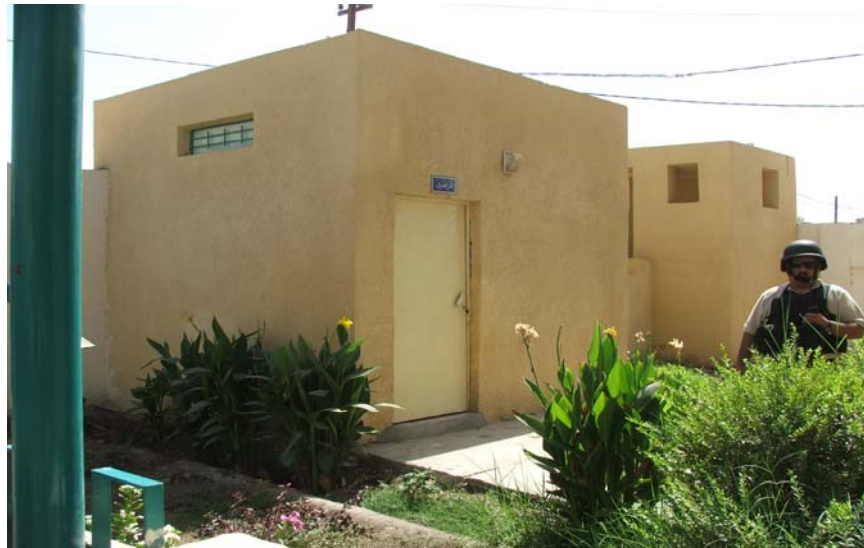
Site Photo 9. Exterior View of the Information Building
